## U.S. Navy Study Proves Effectiveness of EMS Heat Control Technique

# **Solder Comparison on Turret Style Test Vehicles**

Nicholas Clore - SAIC, Merrville, IN

January 14, 2011

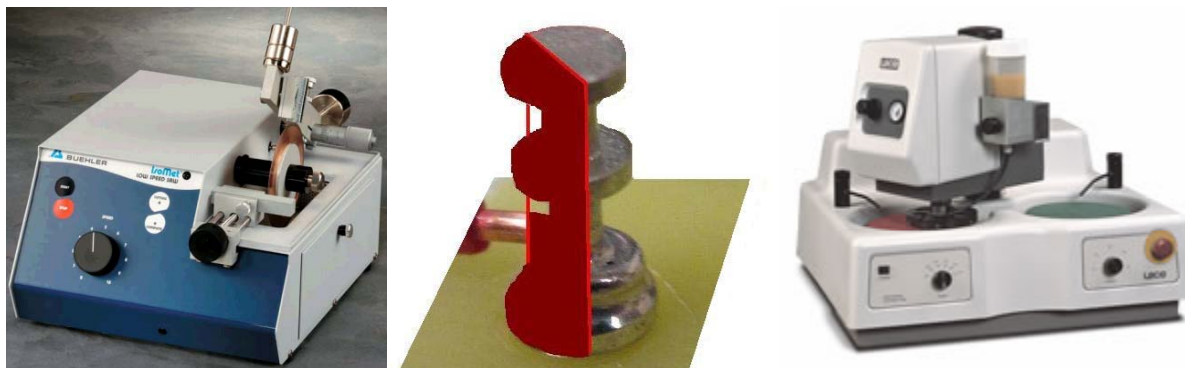
**FIGURE 1** (*left*) Isomet low speed saw by Buehler. ([www.buehler.com](http://www.buehler.com)) (*center*) Area removed using Isomet saw. (*Right*) LECO Spectrum 1000 ([www.purdue.edu/mse](http://www.purdue.edu/mse))

Turrets were isolated from the board by cutting the glass/epoxy board using metal shears. Each turret was then cut slightly off center according to *Figure 1* using a Buehler Isomet low speed saw. Each turret was cut off center to account for material lost during grinding. The specimens were then cleaned using soap and water then dried to remove oil residue. Two specimens were then set in Buehler Epoxicure resin and harder. Epoxicure was used because it sets at a low temperature and would not change the “as received” metallurgy. The mounted specimens were then ground/polished by hand using a LECO Spectrum 1000 and 400, 600, 1200 grit SiC grinding wheels. Special attention was given while grinding to ensure that each specimen would represent a cross-section cut down the center of the turret. The samples were cleaned using distilled water between each grit size progression. The samples were polished on cloth using 0.05  $\mu\text{m}$  Alumina from Buehler and distilled water mixture. Colloidal Silica was then used to polish and etch the solder to enhance the microstructure. Distilled water and ethanol were used to clean and dry the samples after each fine polishing step. The final polished mounted sample is pictured in *Figure 2*. The samples were investigated using optical and electronic microscopy highlighted in *Figure 3*.

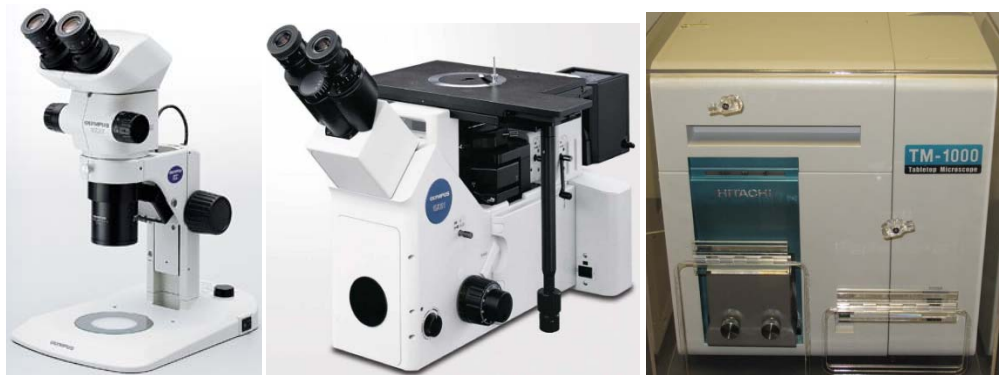
**FIGURE 3** (left) Olympus SZX7 stereoscope (center) Olympus GX51 inverted microscope and (right) Hitachi TM-1000 tabletop SEM.
